# **Empirical Validation of the Conceptual Design of the LLNL 60-kg Contained-Firing Facility**

**John W. Pastrnak  
Charles F. Baker  
Larry F. Simmons**

## **Abstract**

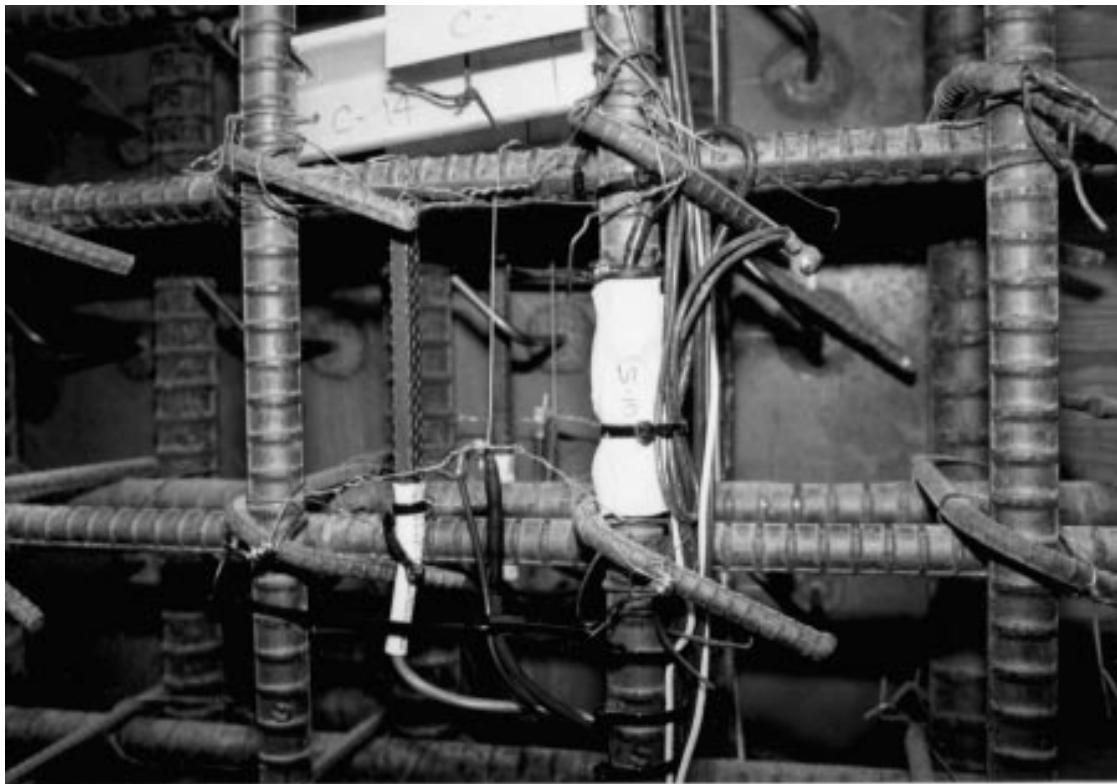
**Figure 16.** Concrete strain gauges C7 and C14 on the outside of the north wall. Note J hooks on the pressure liner in the background.

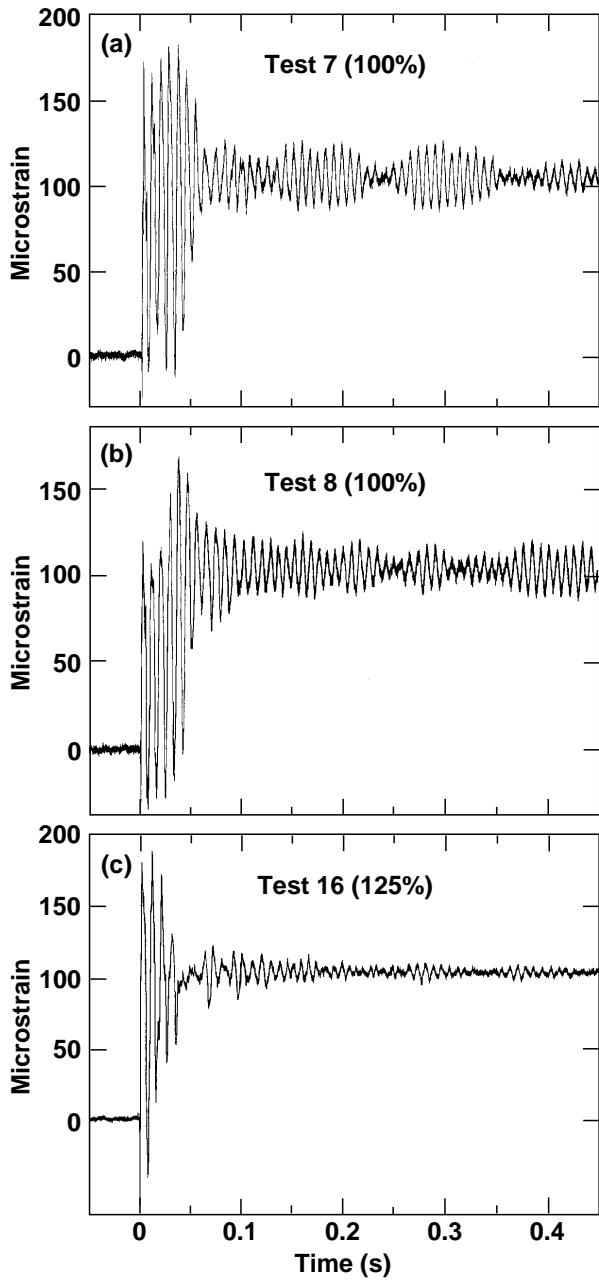
6. As expected from cracked section concrete design, it appears that tensile yielding (i.e., cracking) of the concrete increases the damping of the vibrational response of the structure. This can be seen by examining Fig. 26, which gives a chronological history of the strain in the concrete

of the north wall (gauge C7) prior to and during yielding. This figure also gives evidence of strain relaxation and redistribution by the reduction in the peak strain value from (a) to (b). It is not clear that this cracked section behavior is desirable from a repeated use standpoint, in that it may not be compatible with the original design criteria of an infinite-life elastic response. Clearly, the long-term behavior after cracking has not been tested in these experiments, and further study is recommended.

**Figure 26.** Damping increased, possibly because of cracking in the concrete in the north wall of the chamber (gauge C7).

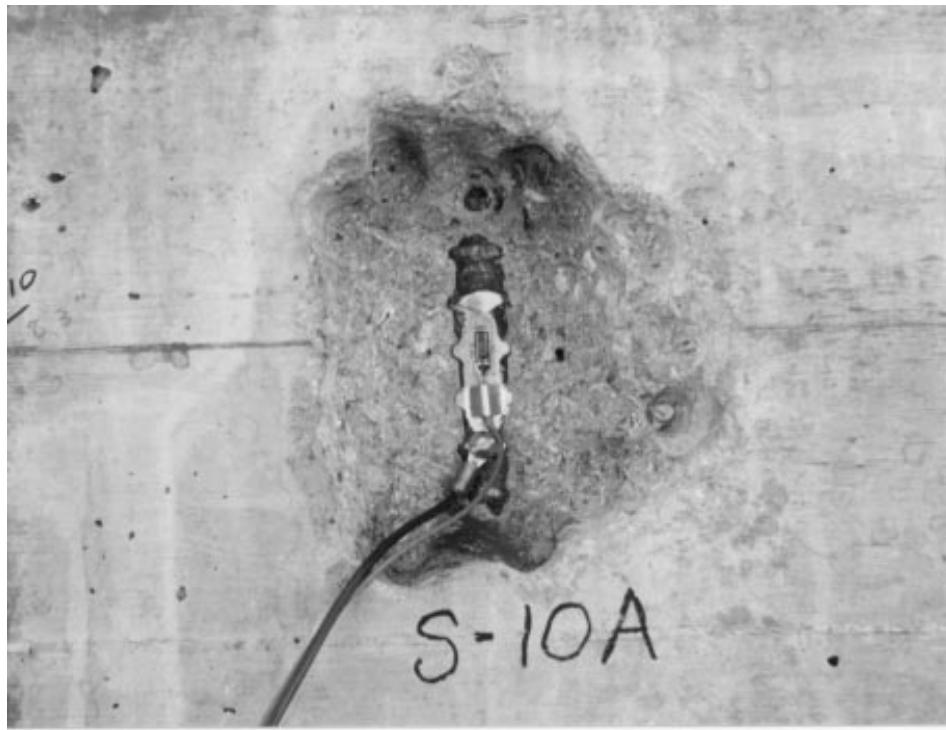
Prior to the first test, a problem developed with some of the weld-on strain gauges attached to the rebar. Their electrical resistance had increased over a weekend to such an extent that they could not be balanced without changing resistors in the Wheatstone bridge circuit. Eventually over the next 2 months, the resistance of 19 of these gauges continued to increase rapidly toward an infinite resistance condition (open circuit). To obtain strain readings at three important failed gauge locations, replacement foil strain gauges were mounted on the rebar prior to test #7. The replacement gauges were mounted at the center of the ceiling on the inner mat, at a northeast corner wall haunch bar, and on the outer mat of the north wall (S14, S26, S10). Access to the rebar in these areas was gained by

chipping away the concrete cover to a depth of about 1.5 in. thick by 6 in. across. Then the new gauges and their signal wires were sealed against moisture and protected with a 1/4-in.-thick steel plate. No attempt was made to patch the chipped-away concrete. The foil replacement gauges performed flawlessly for the remainder of the tests. Due to budgetary restrictions, the failed gauges were not removed and dissected. The most widely held theory for their failure is corrosion within their stainless-steel jackets.

8. Unexpectedly, about half of the steel rebar strain gauges failed just before and just as testing started. Although this was unfortunate, we overcame this condition by replacing strain gauges during mid-testing and successfully obtained rebar strain at important points (see Fig. 27). Since similar strain gauges are planned to be used in the full-size chamber to monitor its dynamic response over its lifetime, it is recommended that these failures be investigated to determine the exact cause so that they may be prevented in the future.

Figure 27. Replacement strain gauge added to rebar after concrete was cured.
